PROJECT TUGBOAT: EXPLOSIVE EXCAVATION OF A
HARBOR IN CORAL

February 1972

TECHNICAL REPORT E-72-23

**U. S. Army Engineer Waterways Experiment Station
Explosive Excavation Research Laboratory
Livermore California**

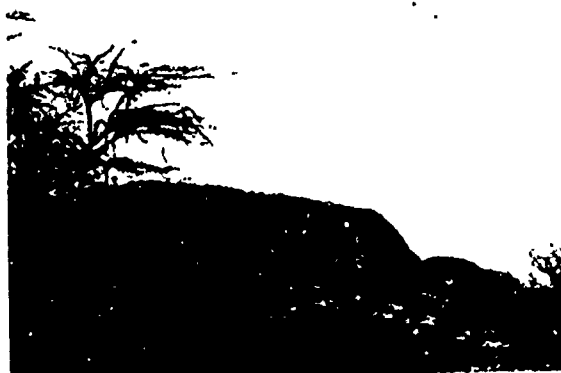
Fig. 12. Bracing on steep wall of Puukohola heiau prior to detonations in Phase I of Project Tugboat.

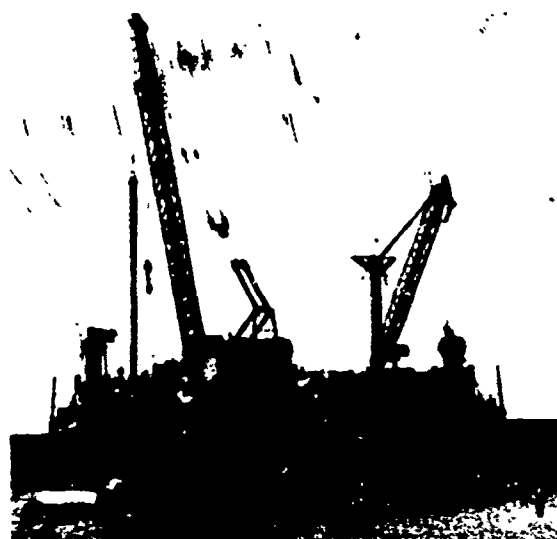
Fig. 20. Drilling platform used during Phase II emplacement construction.

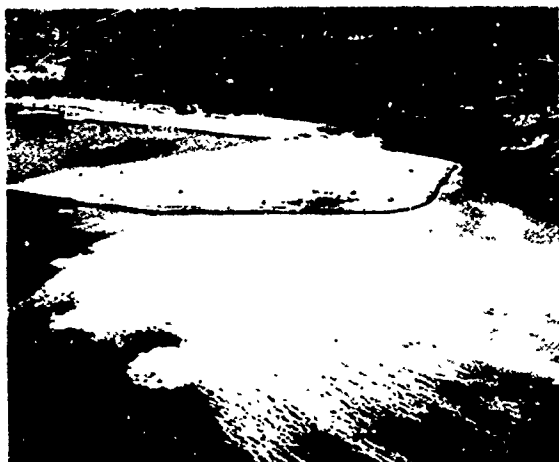
Fig. 81. Whirlpool effect observed following Detonation II-EF.
